**ENFIELD RIFLES: THE COMPOSITE CONSERVATION OF OUR
AMERICAN CIVIL WAR HERITAGE**

A Thesis

Submitted to the Office of Graduate Studies of
Texas A&M University
in partial fulfillment of the requirements for the degree of

December 2008

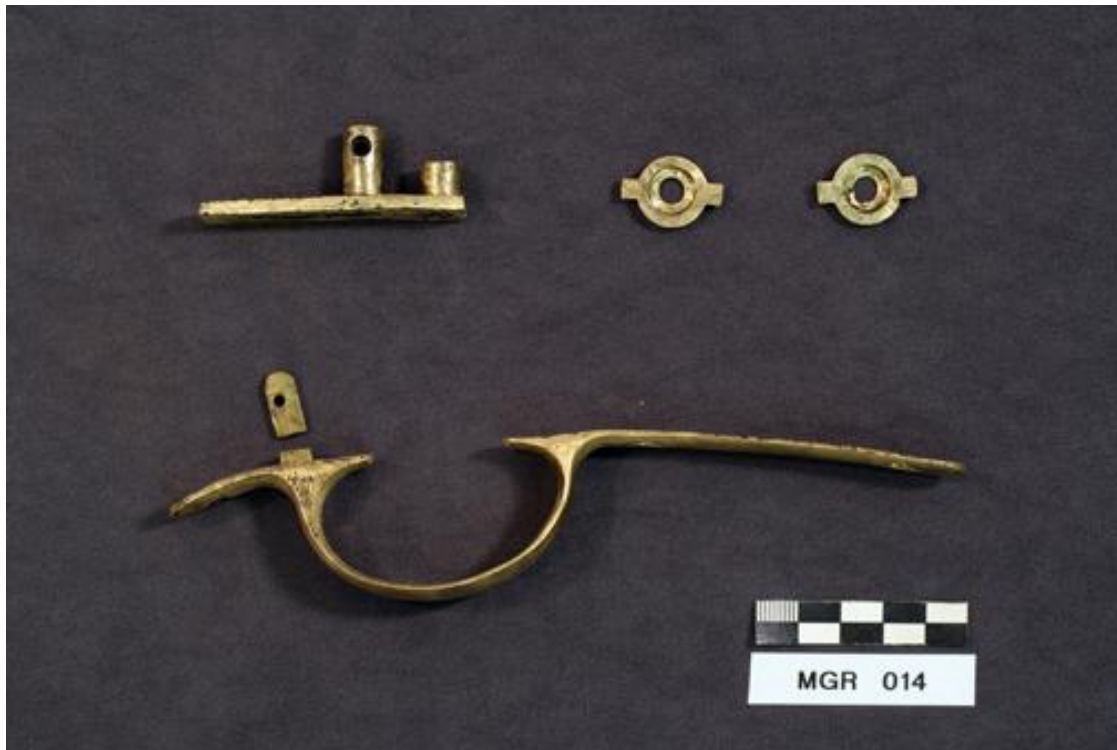
The brass from MGR 014 is the best preserved of all the elements, and following conservation, maker's marks were discovered. A complete chart of these marks, as well as the marks from the other four rifles being discussed can be found in Appendix C. This chart also shows the marks from the remaining five Enfield rifles not being discussed in this thesis. The brass furniture present on this rifle consists of two escutcheons, a trigger plate, a trigger guard, and the nose cap (figure 12). A brass butt plate probably also survived, but it was not shipped to this lab for conservation. The escutcheons measure 2.3 cm long, 1.7 cm tall, and 0.3 cm and 0.4 cm thick. The conservation turned out well, but one escutcheon suffered some damage to the inner ring upon removal from the wood. The trigger plate is 6.1 cm long and approximately 1.3 cm wide. The plate aspect of the trigger plate is 0.3 cm thick, while the tang bolt receiver and trigger pivot rise above this 0.8 cm and 1.65 cm. The tang bolt receiver is 1 cm in diameter, while the trigger pivot is 0.95 cm in diameter. The maker's marks found on the trigger plate are the number 4 and the letter H (figure 13). The trigger guard measures 18.8 cm long, with the tang measuring 1.8 high, and the guard 3.4 cm high. The width is 1.4 cm to 2.15 cm, and the thickness varies from 0.2 cm to 0.4 cm. The maker's marks found on the trigger are the letters G.II and the number 4 (figure 13). The nose cap measures 2.5 cm in length, 2.4 cm and 2.1 cm in height at each end, 2.5 cm in width, and is 0.9 cm thick at the end. This is the only nose cap that has completed conservation at this time. The nose caps remain attached to the wood stocks, and therefore will not be completed until after the wood is finished.

Figure 12. MGR 014 brass furniture (Photo by R. Sasaki).

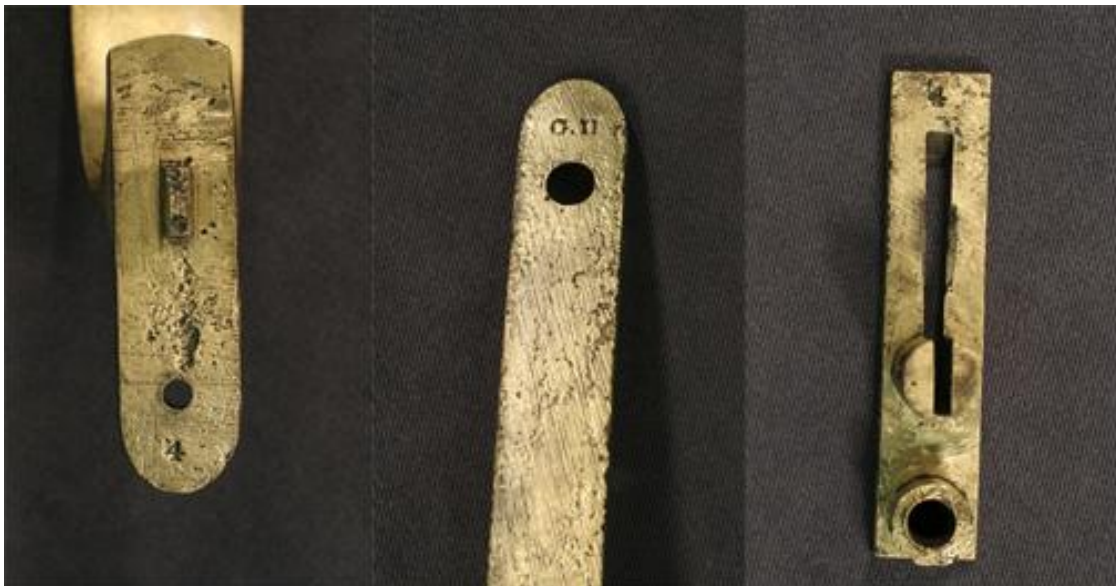
Figure 13. MGR 014 maker's marks on trigger guard and trigger plate (Photos by R. Sasaki).

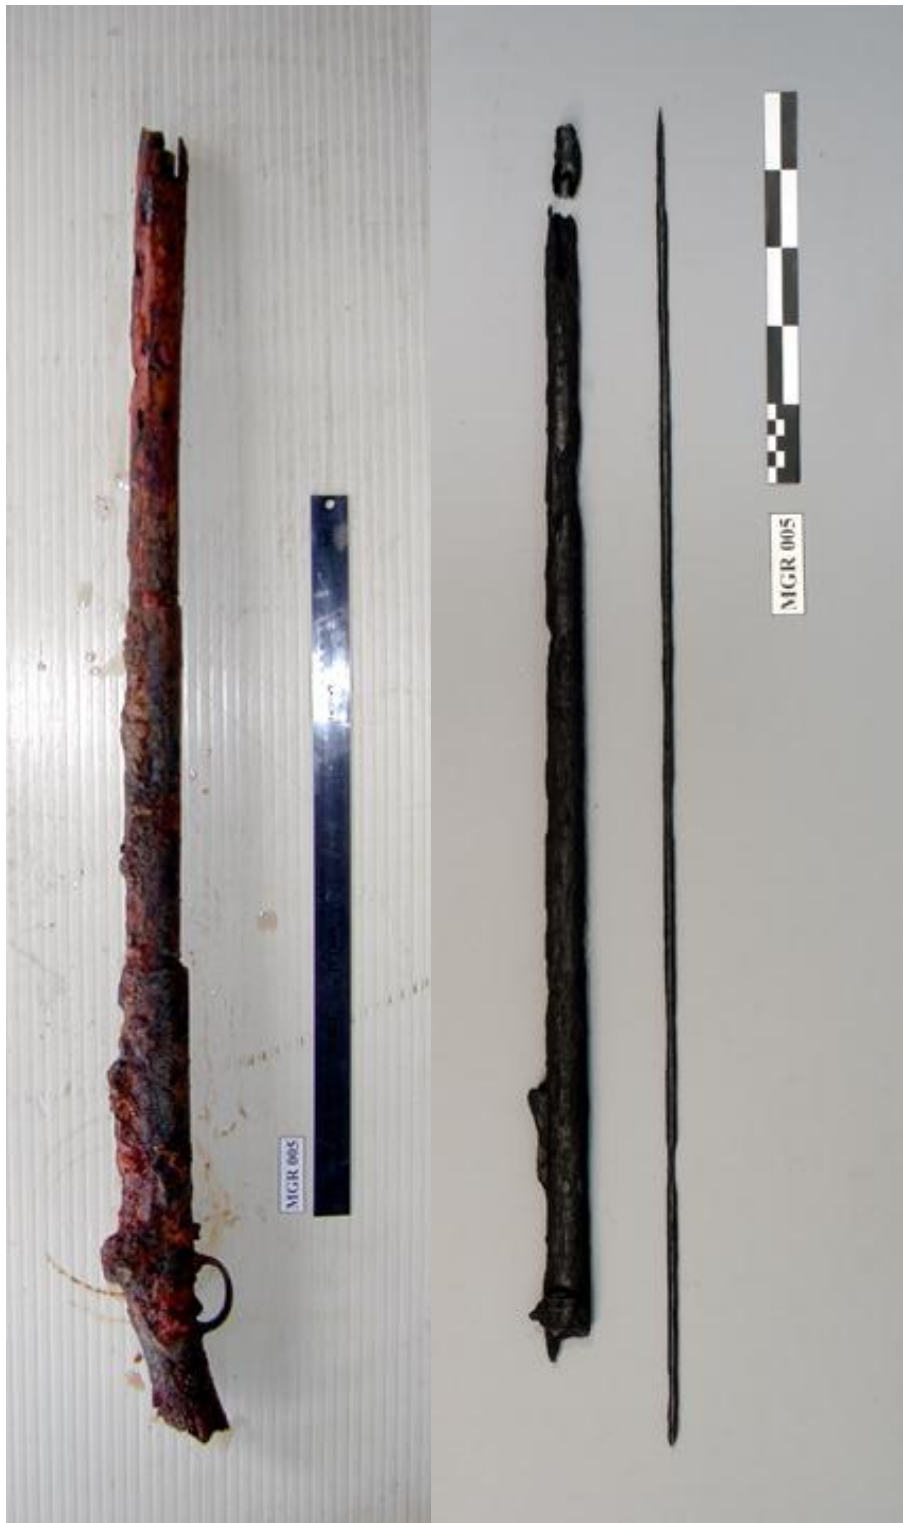
Figure 14. MGR 005 pre-conservation (Photo by S. Cox) and post-conservation barrel and ramrod (Photo by R. Sasaki).

Due to the results of MGR 014, the conservation of the wood for MGR 005 (figure 14) is incomplete. Therefore, only preliminary measurements are available for the stock, and we cannot yet discuss the results of the wood. The length of the stock is 107.5 cm. the stock is 5.0 cm wide at the lock and 3.0 cm wide just before the nose cap. The stock measures 5.5 cm tall at the lock and 2.3 cm just before the nose.

Considering the amount of iron present after 100 years in the ocean, the conservation turned out well. Many parts were still present, although none were complete. Surviving pieces of iron include the lock plate with attached hammer, two pieces of the barrel, the ramrod, and the ramrod spring (figures 14 and 15). The lock plate measures 11.3 cm long, 3.0 cm tall, and 0.35 cm thick. The word “TOWER” is stamped into the lock plate in front of the hammer, however, this word was not visible on any image. This is the only rifle with any remaining maker’s marks found on iron. The hammer measures 5.6 cm tall, 3.4 cm wide across the head, and 1.4 cm thick across the head. The main part of the barrel is 73.7 cm long and tapers from 2.6 cm to 1.9 cm in diameter. The small section of barrel measures 4.6 cm long, 1.6 cm wide, and 1.4 cm tall. Height is being measured on this piece instead of diameter because it has been flattened and no longer retains its original shape. The ramrod measures 85.4 cm long and is 0.6 cm in diameter. The ramrod spring is 5.3 cm long, 0.6 cm wide, and 0.2 cm to 0.3 cm thick.

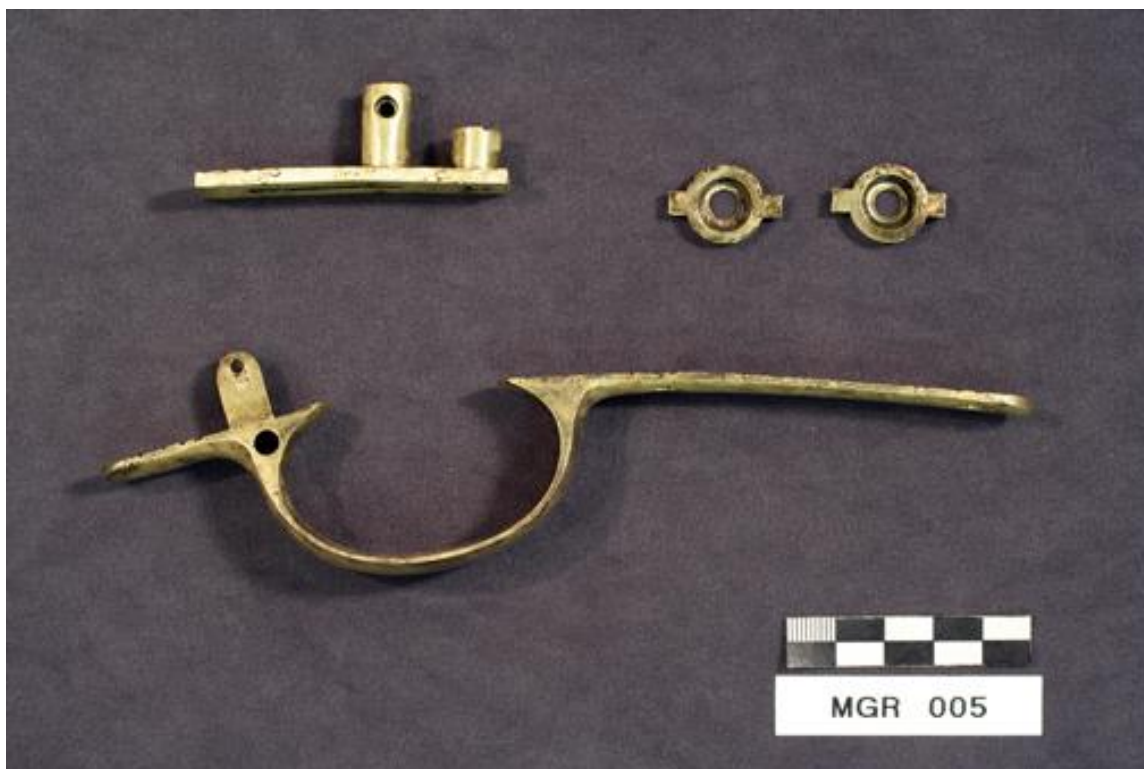
The brass from MGR 005, like MGR 014, is the best preserved of all the elements, and in the post-conservation stage maker's marks were discovered. The brass furniture present for this rifle consists of two escutcheons, a trigger plate, a trigger guard, and the nose cap (figure 16). The escutcheons measure 2.3 cm long, 1.6 cm tall, and 0.3 cm thick. The trigger plate is 6.2 cm long and 1.3 cm wide. The plate aspect of the trigger plate is 0.3 cm thick, while the tang bolt receiver and the trigger pivot rise above this 0.85 cm and 1.7 cm. Both the trigger pivot and the tang bolt receiver are 1.0 cm in diameter. The maker's marks found on the trigger plate include a sideways H, the letters DB, the number 1, and three notches (figure 17). The trigger guard measures 19.0 cm

Figure 16. MGR 005 brass furniture (Photo by R. Sasaki).

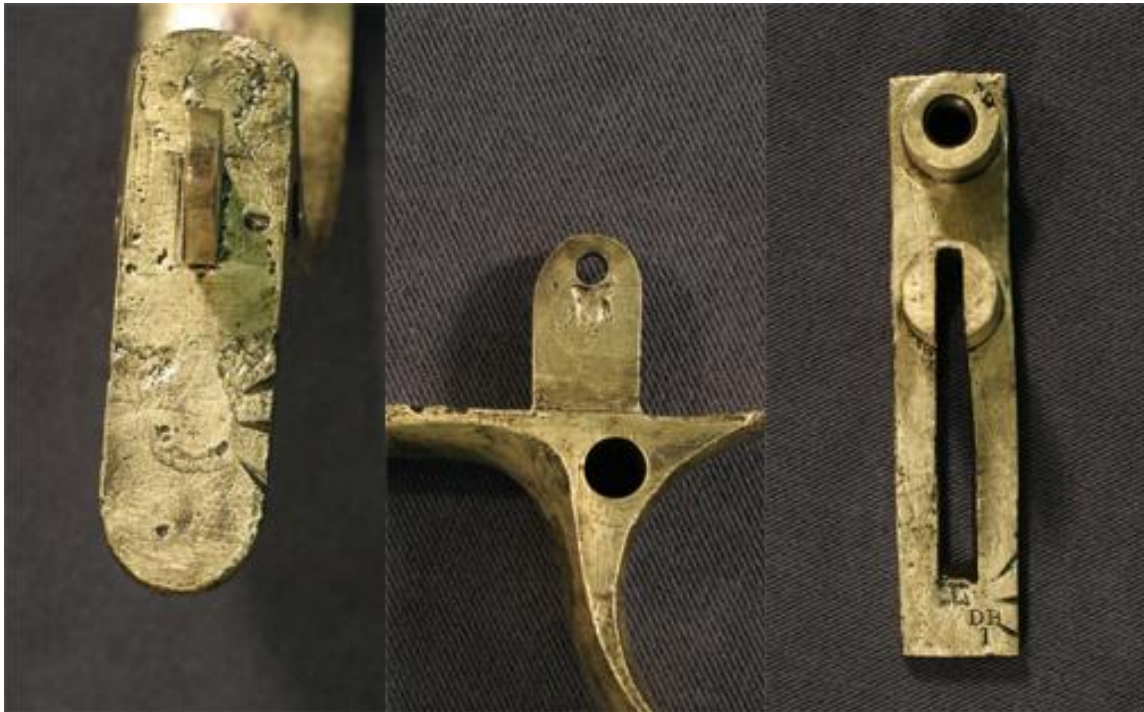
long, with the tang measuring 1.5 cm high, and the guard 3.5 cm high. The width is 1.3 cm to 2.1 cm, and the thickness varies from 0.2 cm to 0.4 cm. The maker's marks found on the trigger guard include the letter H and three notches (figure 17). The nose cap measures 2.5 cm in length, 2.2 cm and 1.9 cm in height at each end, 2.5 cm in width, and is 0.9 cm thick at the end.

Figure 17. MGR 005 brass maker's marks on trigger guard and trigger plate (Photos by R. Sasaki).

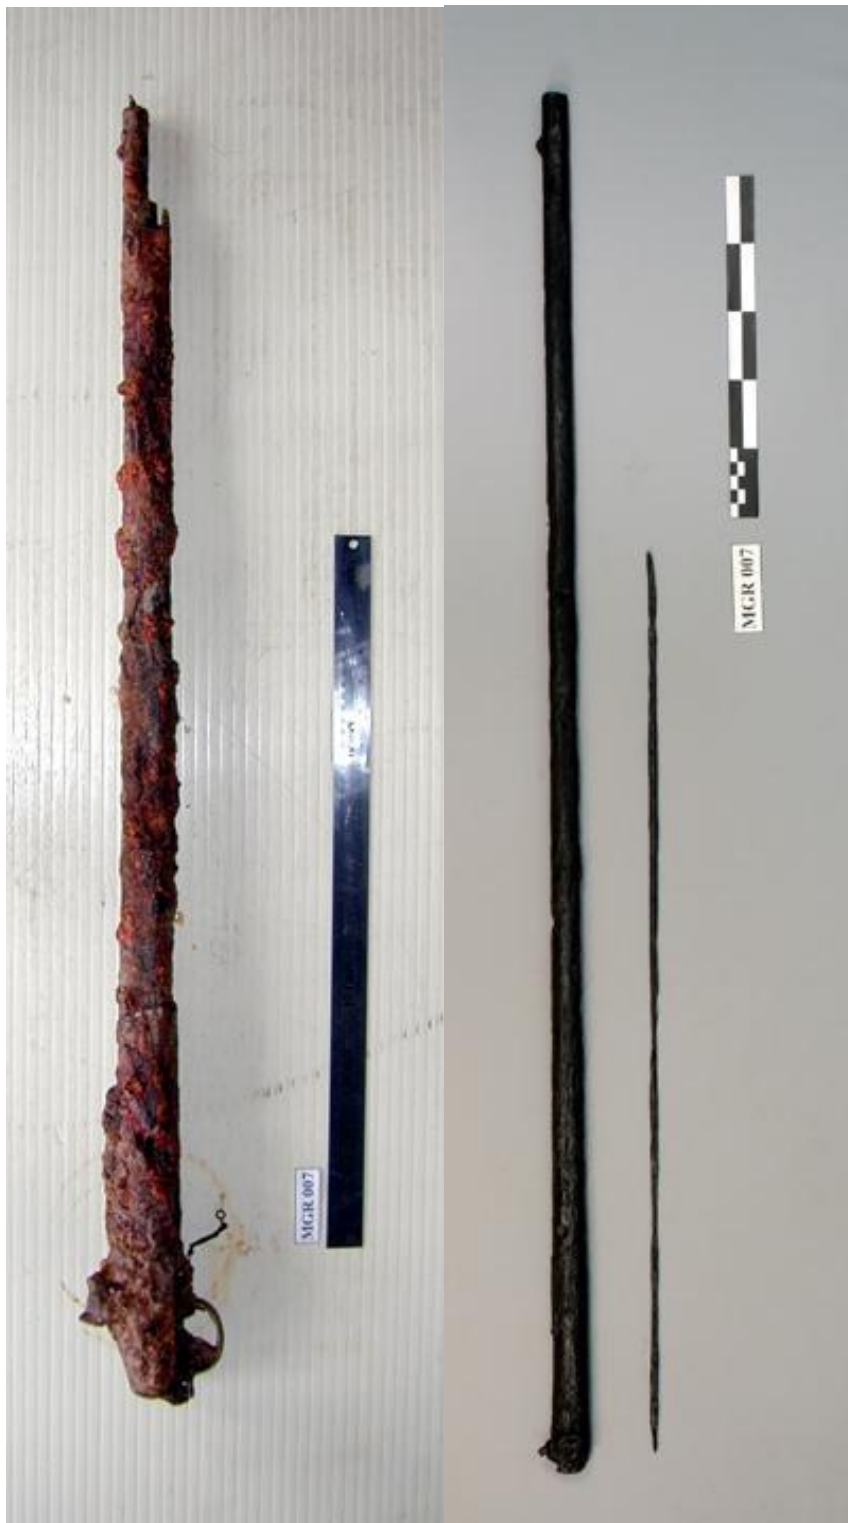
Due to the results of MGR 014, the conservation of the wood for MGR 007 (figure 18) is incomplete. Therefore, only preliminary measurements are available for the stock, and we cannot yet discuss the results of the wood. The length of the stock is 102.0 cm. the stock is 5.0 cm wide at the lock and 2.7 cm wide just before the nose cap. The stock measures 6.0 cm tall at the lock and 2.3 cm just before the nose.

Figure 18. MGR 007 pre-conservation (Photo by S. Cox) and post-conservation barrel and ramrod (Photo by R. Sasaki).

The surviving iron from MGR 007 includes the lock plate with hammer, tumbler, and bridal attached, barrel, ramrod, mainspring, swivel, and rear sight (figures 18 and 19). The lock plate measures 9.9 cm long, 2.9 cm tall, and 0.1 cm thick. The hammer measures 6.8 cm tall, 3.3 cm wide across the head, and 1.3 cm thick across the head. It is not possible to obtain diagnostic measurements from the corroded tumbler and bridal. The barrel measures 100.1 cm long and tapers from 2.6 cm to 1.8 cm in diameter. The ramrod measures 65.6 cm long and 0.3 cm to 0.6 cm in diameter. The mainspring is in two pieces and they measure 4.5 cm and 3.2 cm in length and they are 0.15 cm thick. The swivel measures 3.7 cm long, 1.4 cm tall, and has a diameter of 0.5 cm thick. The rear sight measures 5.6 cm in length, 1.8 cm in width, and 0.7 to 1.3 cm tall.

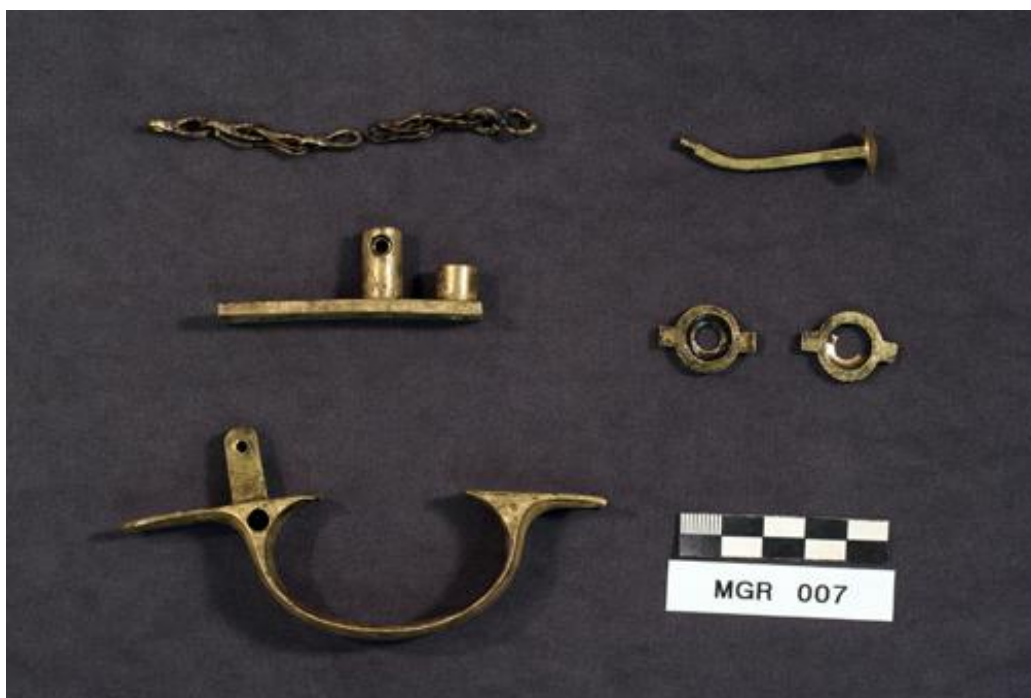
MGR 007 has more brass furniture than any of the other rifles. The brass furniture includes two escutcheons, a trigger plate, a partial trigger guard, the brass screw from a tampion plug, the nipple cap chain, and the nose cap (figure 20). The escutcheons are 2.35 cm and 2.3 cm in length, 1.6 cm wide, and 0.3 cm and 0.2 cm thick. The smaller of the two escutcheons is missing a good portion of its inner ring. The trigger plate measures 6.15 cm in length, 1.25 cm wide, and 0.3 cm thick. The tang bolt receiver and trigger pivot stand 0.85 cm and 1.2 cm tall, and have diameters of 1.0 cm and 0.95 cm respectively. Four notches were found on the trigger plate (figure 21). The trigger guard measures 11.6 cm in length, and is missing the rear half. No maker's marks were found on the trigger guard, but they probably would have been located on the missing half and mirrored in part the marks on the trigger plate. The guard is 3.4 cm tall, the tang is 1.8 cm tall, and the entire piece varies in thickness from 0.1 cm to 0.4 cm. The tampion screw is 4.7 cm long, 0.25 cm thick with a square cross section, and bent. The head of the screw has a diameter of 1.2 cm and is 0.3 cm thick. The nipple cap chain is in two pieces. Their combined length is 9.1 cm. Each link is approximately 1.55 cm in length, except for the starting link which is 1.7 cm. The width of each link is 0.55 cm except the starting link which is 0.8 cm. The nose cap measures 2.6 cm in length, 2.1 cm and 1.8 cm in height at each end, 2.5 cm in width, and is 0.8 cm thick at the end.

Figure 20. MGR 007 brass furniture (Photo by R. Sasaki).

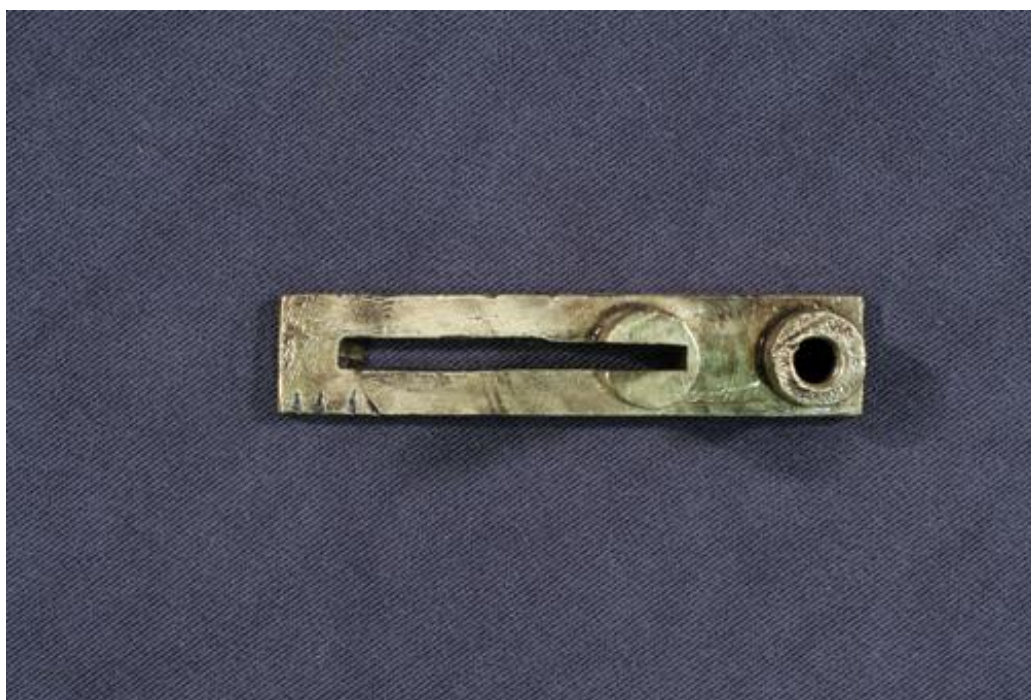
Figure 21. MGR 007 brass maker's marks (Photo by R. Sasaki).

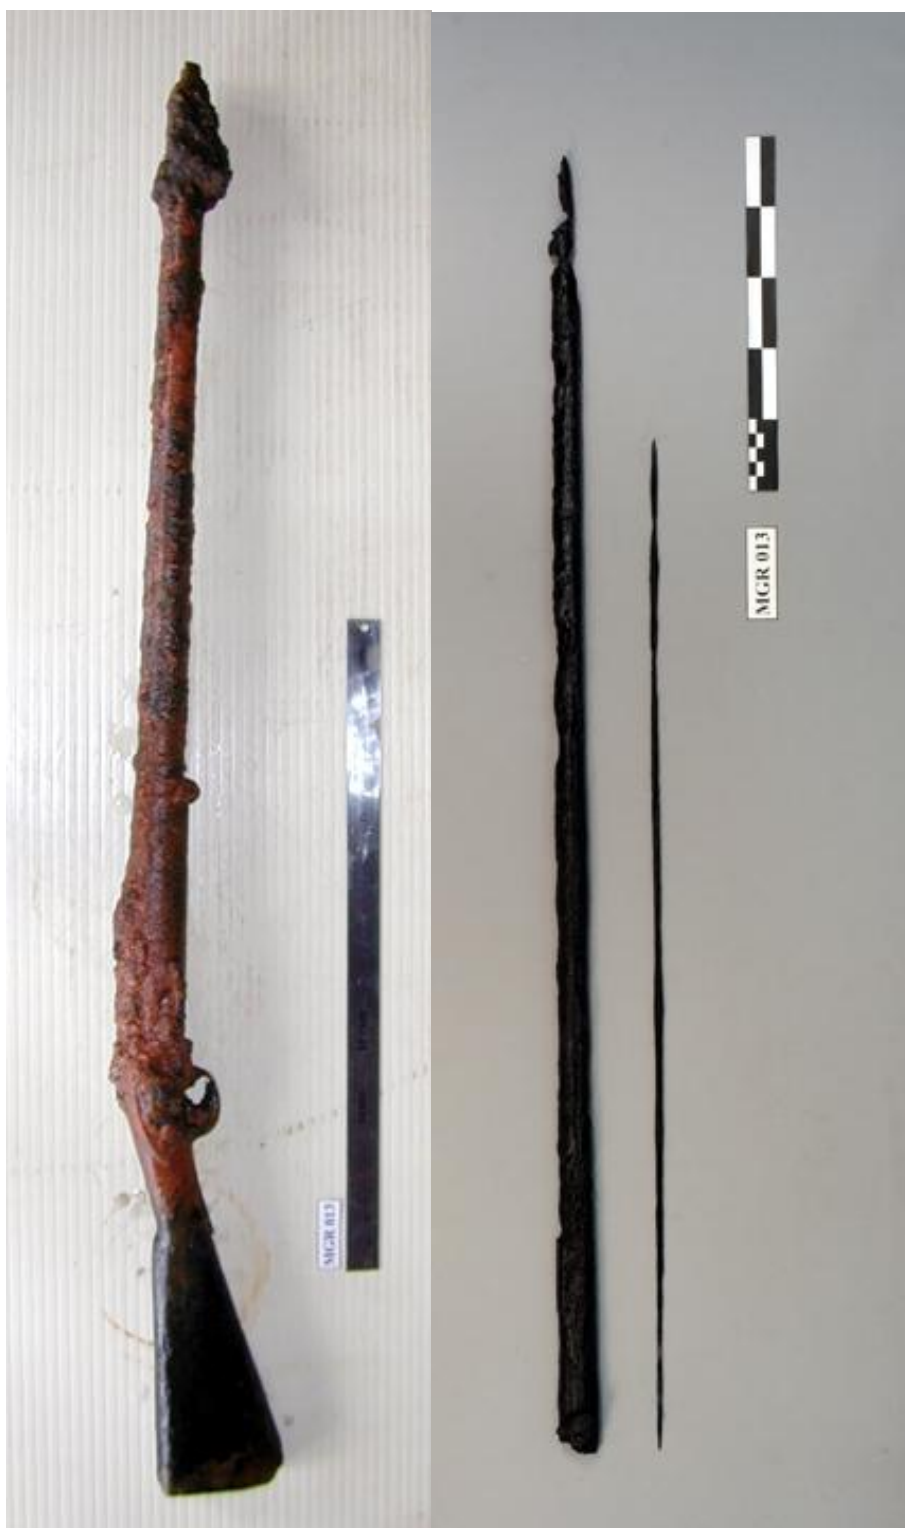
Figure 22. MGR 013 pre-conservation (Photo by S. Cox) and post-conservation barrel and ramrod (Photo by R. Sasaki).

The wood stock from MGR 013 is the longest complete stock (figure 22). The stock measures 130.0 cm. The width of the stock measures 4.5 cm at the butt, 5.0 cm at the lock, and 3.0 cm just before the nose. The height of the stock measures 11.5 cm at the butt, 5.5 cm at the lock, and 2.5 cm just before the nose. This rifle is a true double banded short rifled musket, while the other two rifles with complete stocks are either musketoons or carbines.

The iron that survived on MGR 013 includes a good portion of the lock plate with some attached parts, the barrel, and the ramrod (figures 22 and 23). The lock plate measures 12.3 cm in length, 3.1 cm in height, and is 0.2 cm thick. The bridal is too corroded to obtain any diagnostic measurements, and the stirrup and tumbler are obscured by the bridal. The barrel measures 91.0 cm long, and tapers from 2.85 cm to 1.8 cm in diameter. The ramrod is 71.2 cm long and has a diameter of 0.6 cm. The ramrod spring measures 3.0 cm in length, 0.6 cm in width, and is 0.2 cm thick.

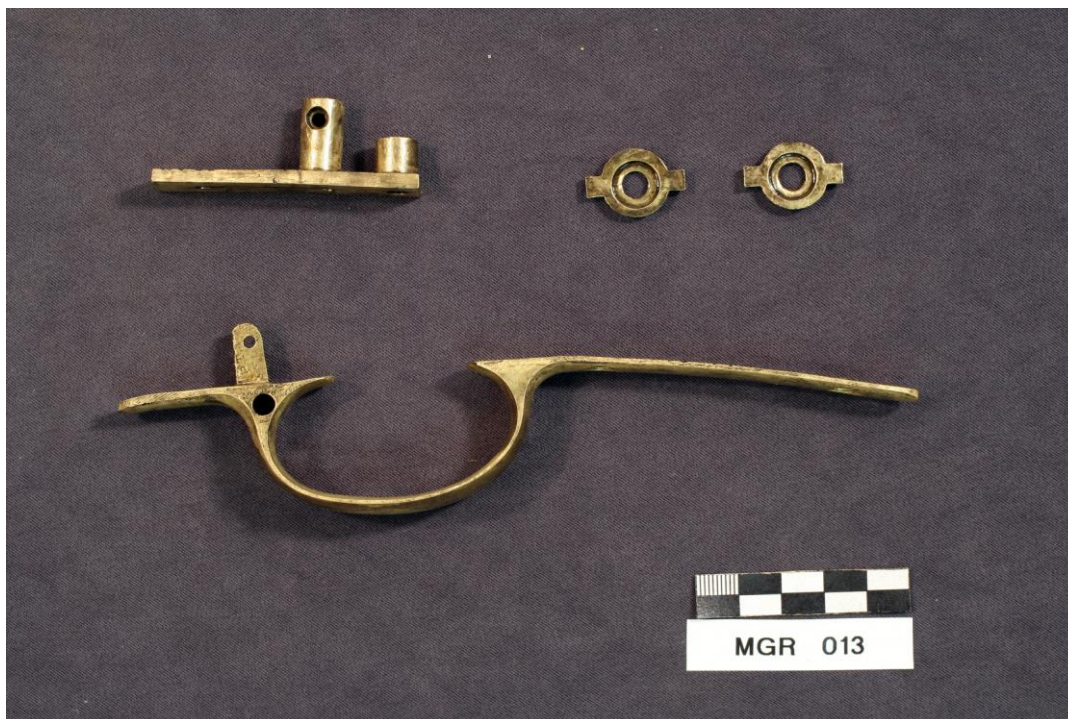
The brass trigger guard, trigger plate, escutcheons, and nose cap all survived in excellent condition (figure 24). The trigger guard measures 18.5 cm long, with the tang measuring 1.4 cm high, and the guard 3.3 cm high. The width is 1.3 cm to 2.0 cm, and the thickness varies from 0.2 cm to 0.4 cm. The maker's marks found on the trigger guard consists of five notches, two of which are crossed (figure 25). The trigger plate measures 6.15 cm in length, 1.25 cm wide, and 0.3 cm thick. The tang bolt receiver and

Figure 24. MGR 013 brass furniture (Photo by R. Sasaki).

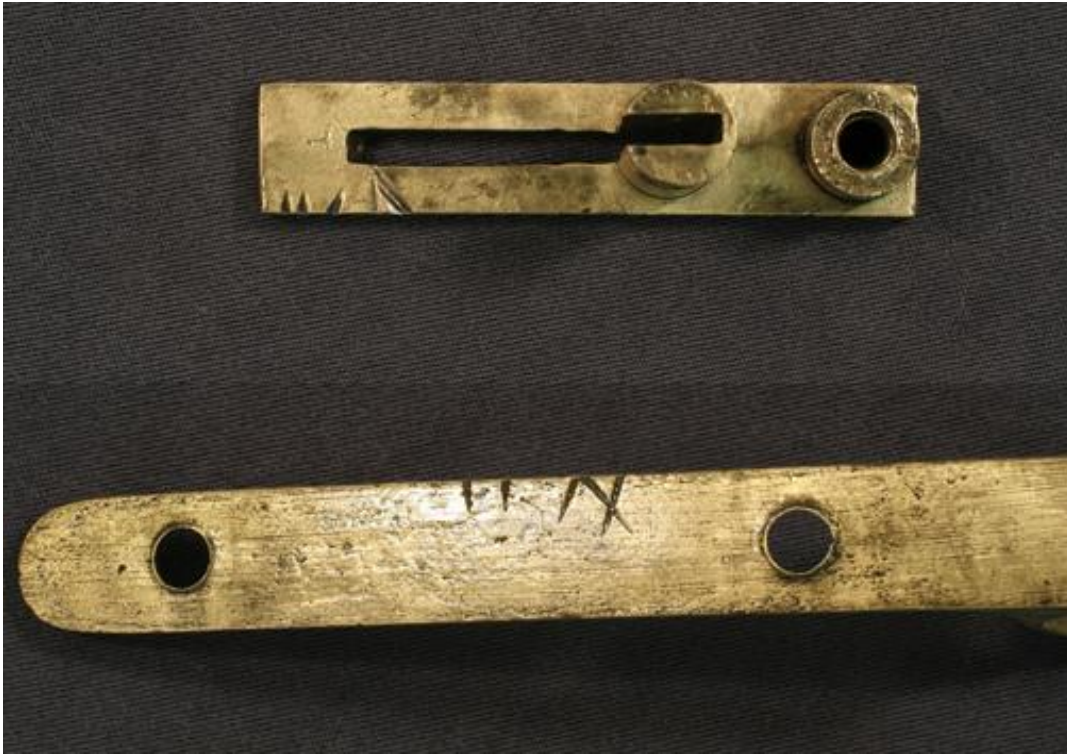
trigger pivot stand 0.85 cm and 1.7 cm tall, both with diameters of 1.0 cm. five notches were found on the trigger plate, with two attempting to cross, and evidence of one mark being re-made. The letter H was also found on the trigger plate (figure 25). The escutcheons are 2.3 cm in length, 1.6 cm wide, and 0.3 cm thick. The nose cap measures 2.6 cm in length, 2.3 cm and 1.8 cm in height at each end, 2.5 cm in width, and is 0.7 cm thick at the end.

Figure 25. MGR brass maker's marks (Photos by R. Sasaki).

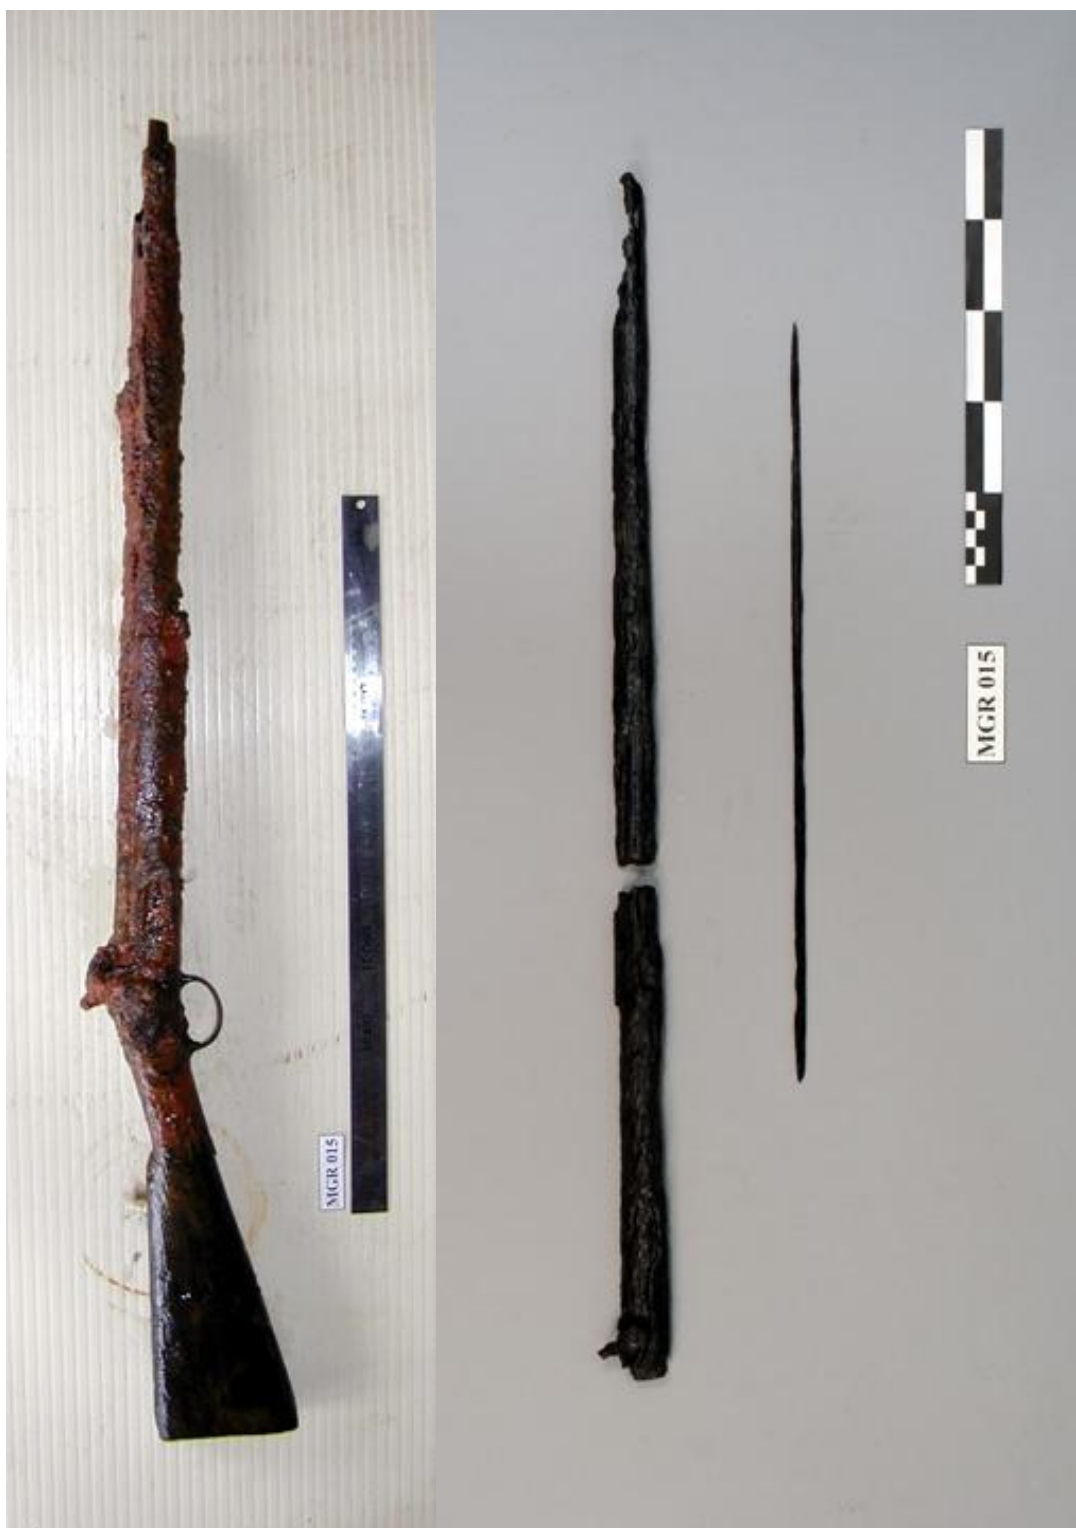
Figure 26. MGR 015 pre-conservation (Photo by S. Cox) and post-conservation barrel and ramrod (Photo by R. Sasaki).

The stock of MGR 015 is most similar to the stock of MGR 014. The stock measures 109.5 cm in length (figure 26). The width of the stock measures 4.5 cm at the butt, 4.5 cm at the lock, and 3.0 cm just before the nose cap. The height measures 12.5 cm at the butt, 5.5 cm at the lock, and 2.5 cm just before the nose cap. While the length is the same, other measurements are not. These rifles were probably of the same type (musketoons or carbines) but were not exact in their manufacture.

The iron that survived includes two pieces of the barrel, a small portion of the lock plate with the hammer, bridal, and tumbler attached, the ramrod, the ramrod spring, and three pieces of the mainspring (figures 26 and 27). The breech end of the barrel measures 27.1 cm in length and tapers from 2.7 cm to 2.5 cm in diameter. The forward section of the barrel measures 38 cm in length and tapers from 2.3 cm to 2.0 cm in diameter. However the end of the barrel is incomplete, so the barrel would have a smaller diameter at the nose. The lock plate measures 8.7 cm long, 2.3 cm tall, and 0.3 cm thick. The hammer measures 6.5 cm tall, 3.5 cm wide across the head, and 1.4 cm thick across the head. The tumbler and bridal are too heavily corroded to gather diagnostic measurements. The ramrod is 41.9 cm long and has a diameter of 0.5 cm. The ramrod spring measures 4.1 cm in length, 0.55 cm in width, and is 0.2 cm thick. The mainspring is in two pieces and they measure 7.1 cm and 3.6 cm in length, 0.5 in height at the intact end, and they are both 0.9 cm wide and 0.1 cm thick.

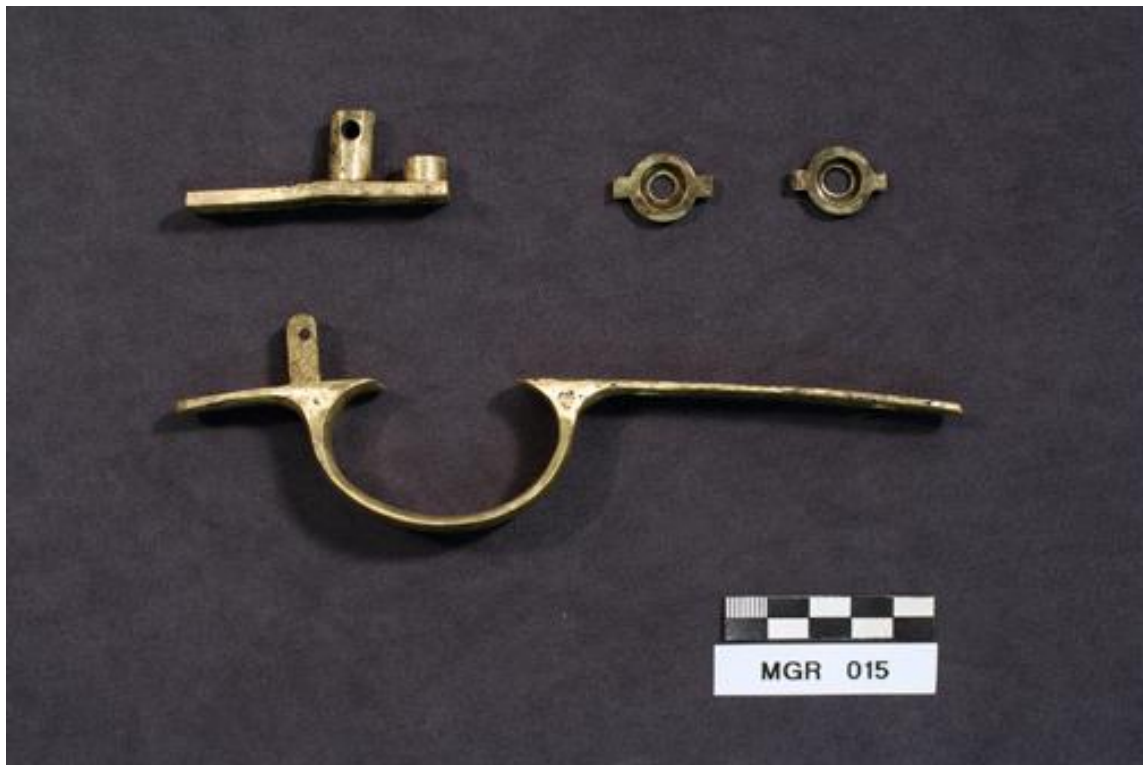
The surviving brass furniture includes the escutcheons, the trigger plate, the trigger guard, and the nose cap (figure 28). The escutcheons measure 2.3 cm in length, 1.7 cm tall, and 0.35 cm and 0.4 cm thick. These escutcheons are the most robust of all the escutcheons. The trigger plate measures 6.0 cm long, 1.2 cm wide, and 0.35 cm thick. The tang bolt receiver and trigger pivot stand 0.6 cm and 1.7 cm tall with diameters of 1.0 cm each. Maker's marks found on the trigger plate include a sideways H, the letters DB, and the number 1 (figure 29). The trigger guard measures 18.4 cm in length and 1.3 cm to 2.0 cm wide. The guard stands 3.5 cm tall, and the tang stands 1.6 cm tall. No maker's marks were found on the trigger guard which may indicate that the trigger guard and trigger plate were made at separate locations. This is highly unusual

for a new firearm. If this rifle had seen action instead of ending up at the bottom of the ocean, one would assume that the trigger guard had been replaced. The nose cap measures 2.5 cm in length, 2.5 cm and 1.7 cm in height at each end, 2.5 cm in width, and is 0.7 cm thick at the end.

Figure 28. MGR 015 brass furniture (Photo by R. Sasaki).

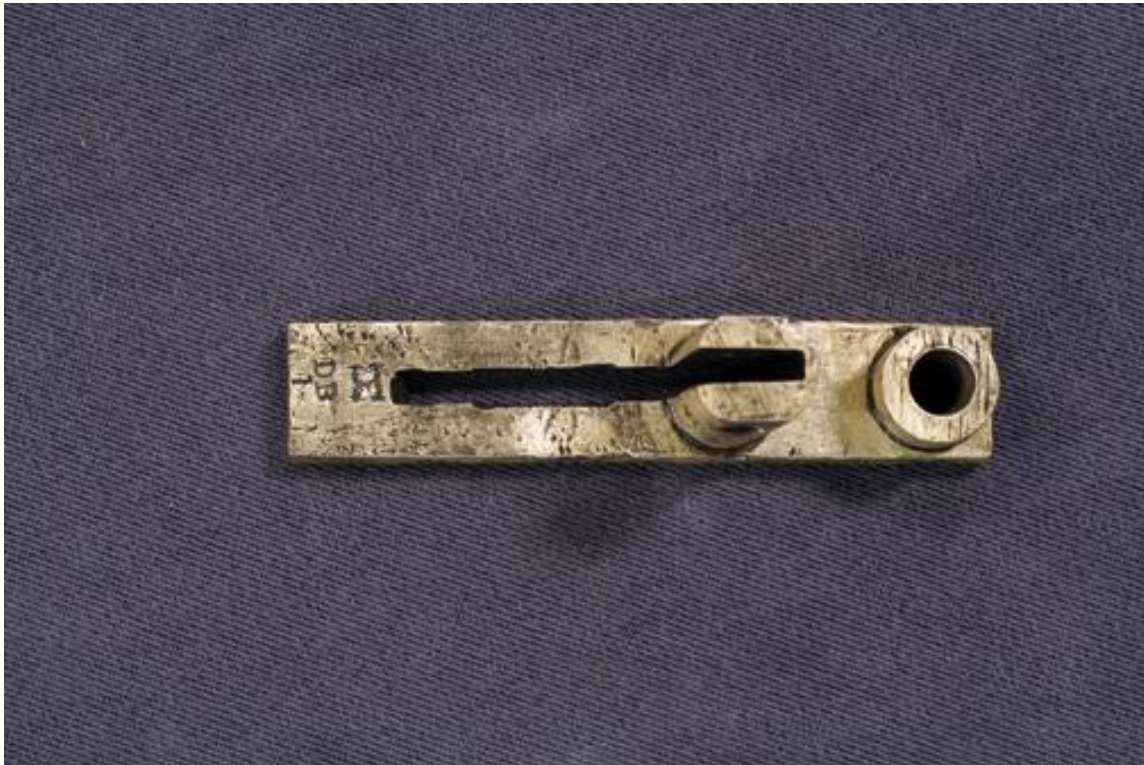
Figure 29. MGR 015 brass maker's marks (Photo by R. Sasaki).
